# **Technical Excursion Jan van Galenstraat**

#### Cycling trough the nineteenth century districts; Amsterdam's bicycle policy in practice

Addy Jonker Traffic Consultant, Dutch Cyclists' Union, Amsterdam division W.G. Plein 84, 1054 RC Amsterdam, Netherlands E-mail: jonker@fietsersbond.nl

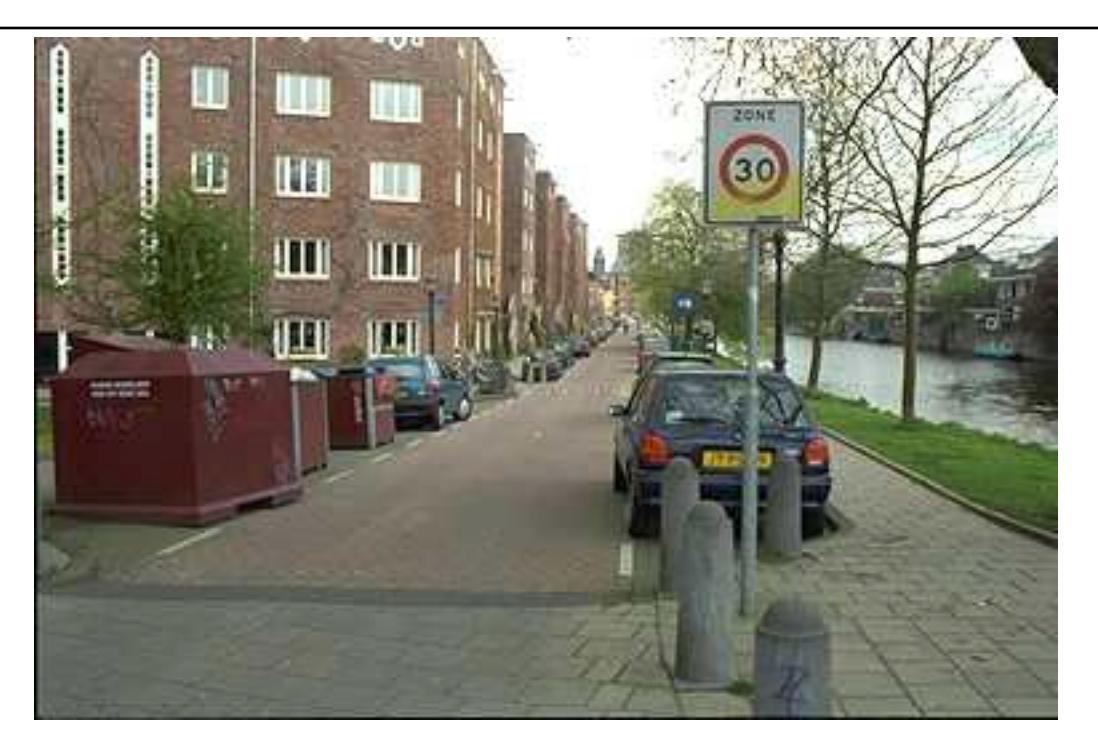
Fig.1. Photo: Vinkeleskade, cycle route in 30 km/h zone

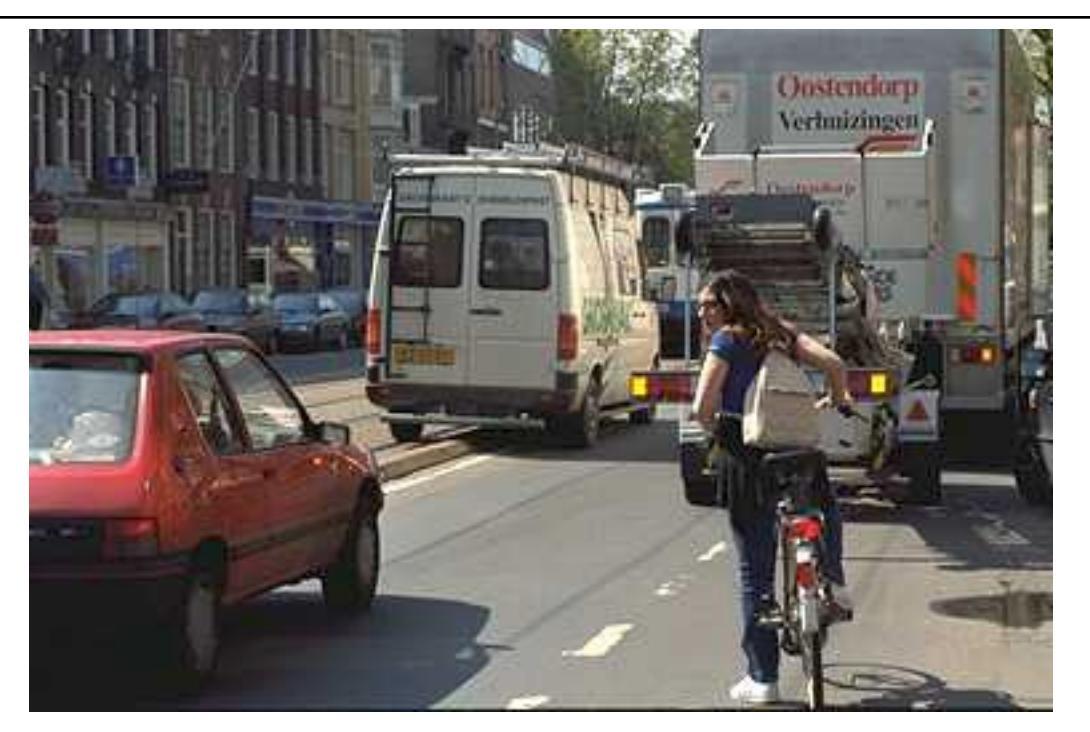
Fig. 2. Photo: Overtoom. Twenty-five per cent of all cycling accidents involving personal injury are caused by illegal parking.

shown that marked cycle lanes do not discourage double-parking. In Amsterdam, twenty-five per cent of all cycling accidents involving personal injury are caused by illegal parking.

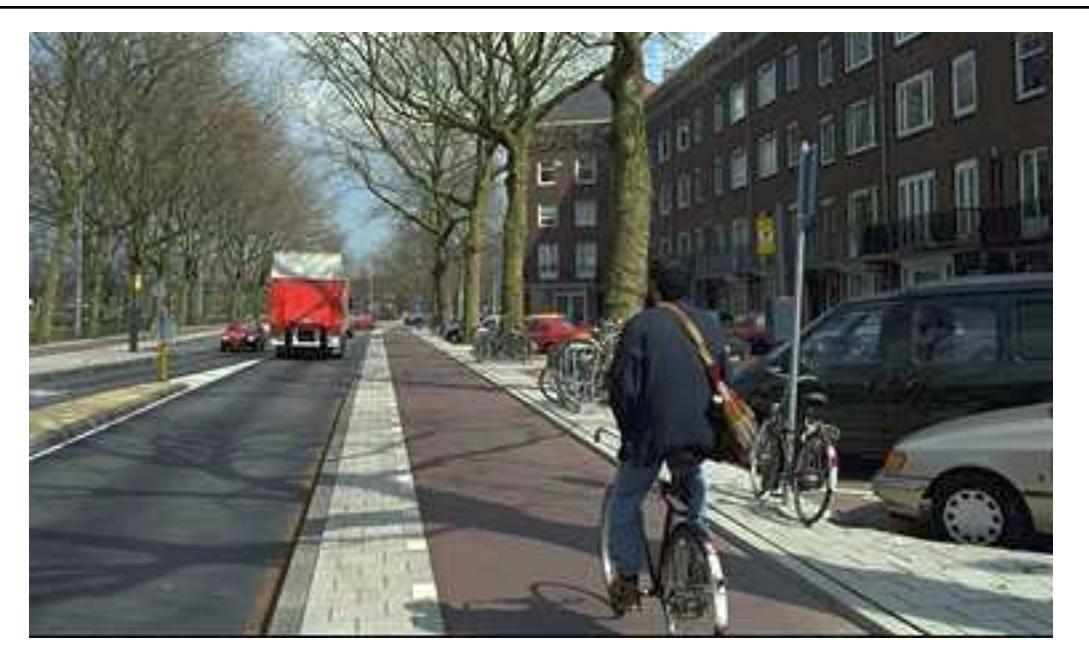
Fig. 3. Jan van Galenstraat following its redesign

After much administrative discussion, it was eventually decided to adopt various physical measures to improve road safety. By prohibiting traffic from turning left at one junction (whereby a filter lane became unnecessary) it proved possible to maintain capacity as required by the City.

The redesigned Jan van Galenstraat was completed in 1999. Not only has road safety for cyclists been significantly improved, the situation for pedestrians is also noticeably better. We may conclude that, although the implementation of Amsterdam's bicycle policy may have been made rather more complicated by the division of the city into individual administrative districts, these districts have been able to play a decisive role in the construction and improvement of the routes within the Main Cycle Network.

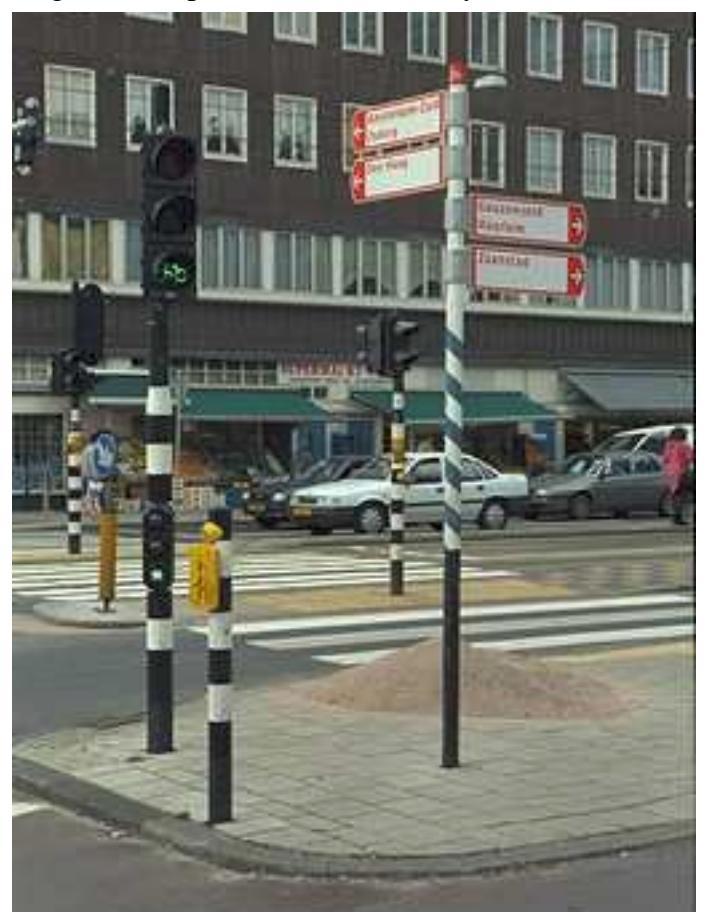
Fig. 4 Direction sign for cyclists

Good signposting is essential to the recognizability of the cycle routes. In recent years, direction signs for cyclists have gradually been introduced throughout Amsterdam. These show the main destinations, reference points, local sights and outlying districts and villages. In many cases, a distinction has been made between a recreational ('scenic') route and a direct utilitarian route. The system of signposting was completed within the last year and is now being evaluated.

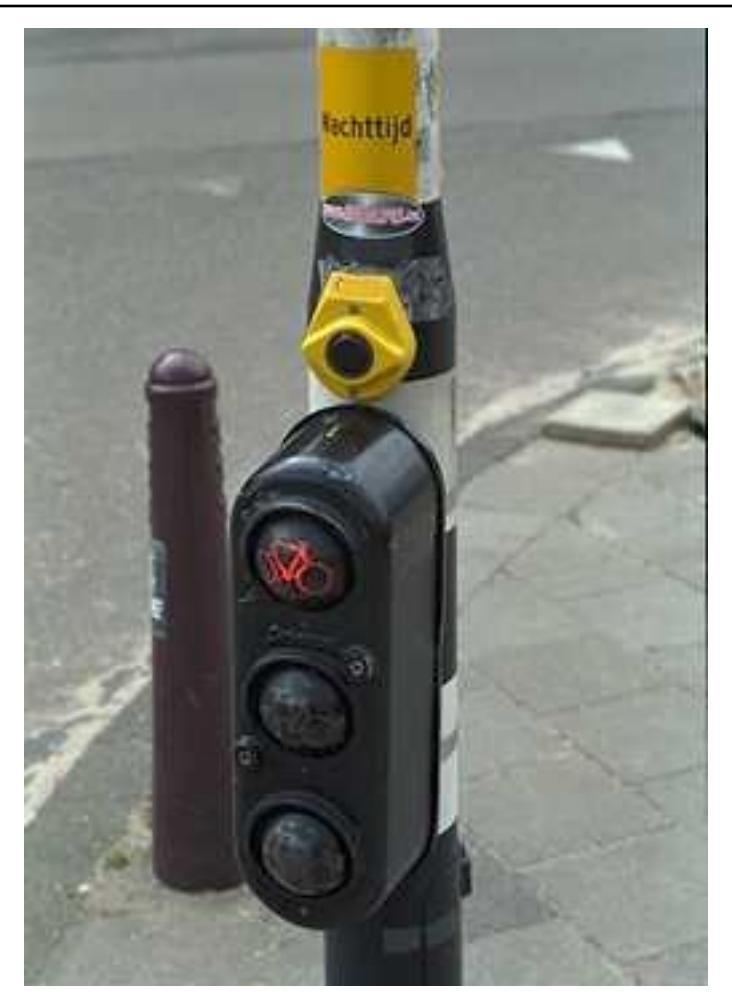
Fig. 5. Traffic light with waiting time indicator for cylcists

Almost all traffic lights in Amsterdam have separate lights for cyclists. In theory, cyclists approaching the lights are detected by loops under the road surface. However, because many modern bicycles are too light to be detected, cyclists' traffic lights are also equipped with a push-button. Experiments are now being conducted with 'waiting time indicators' whereby LEDs not only show the cyclists that their presence has been detected, but also indicate how long they will have to wait for the green light.
